RAILWAY INVESTIGATION REPORT

R05Q0033

MAIN-TRACK DERAILMENT

MILE 21.33, VAL-D'OR SUBDIVISION

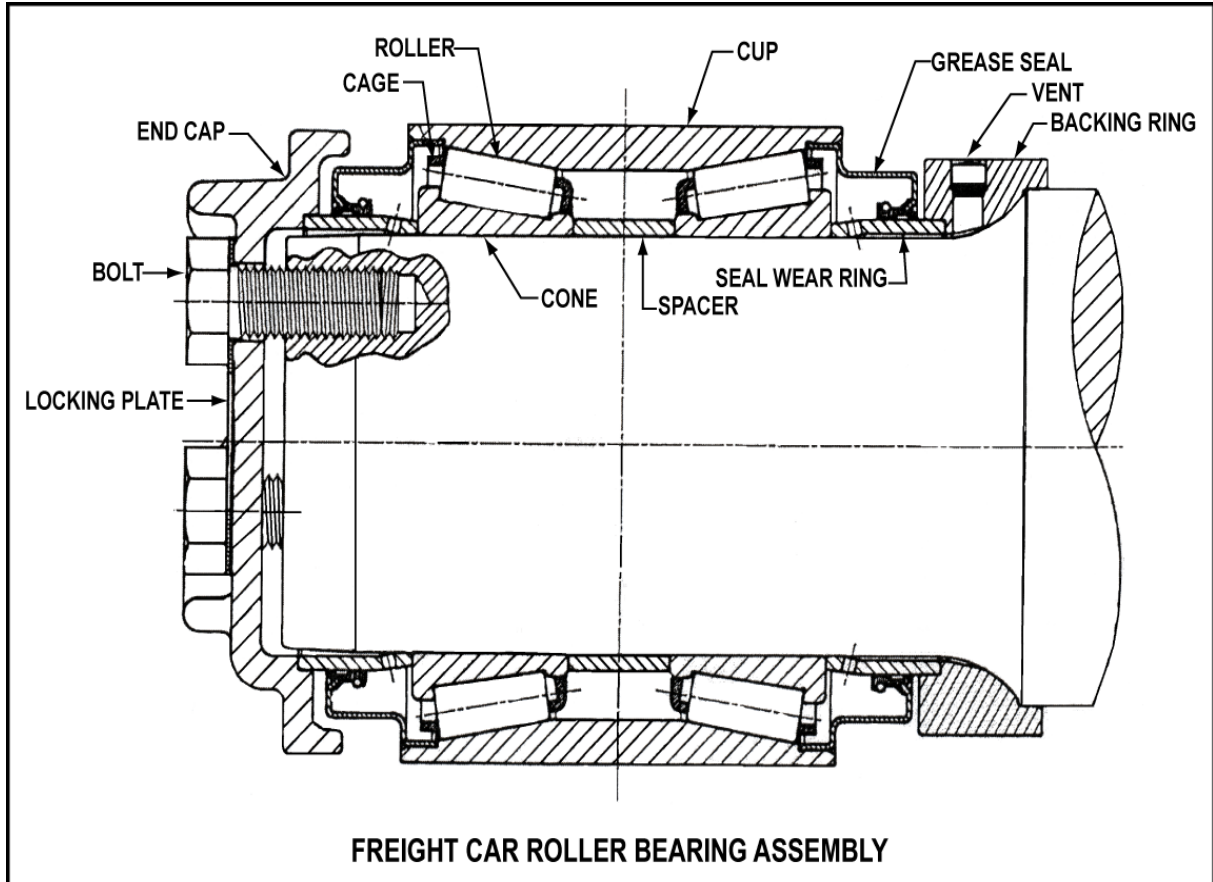
Appendix A – Schematic of Typical Freight Car Roller Bearing Assembly

Roller bearings consist of an outer race, two tapered roller bearings with inner races separated by a spacer, and two (inner and outer) grease seals with wear rings. This assembly is pressed on an axle against a backing ring and then retained by the end cap, which attaches to the end of the axle via three cap screws and a locking plate (see Photo 2 and Appendix A).

The bearings on wheel R-2 were Class E Brenco 6 X 11, AAR-5A. When they were assembled, they were equipped with rubber cap screw seal rings between the end cap and the axle. In May 1988, the AAR prohibited the further use of these cap screw seal rings as they were susceptible to reducing the clamping forces on the assembly, which can contribute to premature failure of the bearing. Examination of the end cap and related components from the R-2 position revealed only residues of these seal rings.
